Evaluation of Wire Harnesses Recently Removed from F-16 Aircraft

Abstract

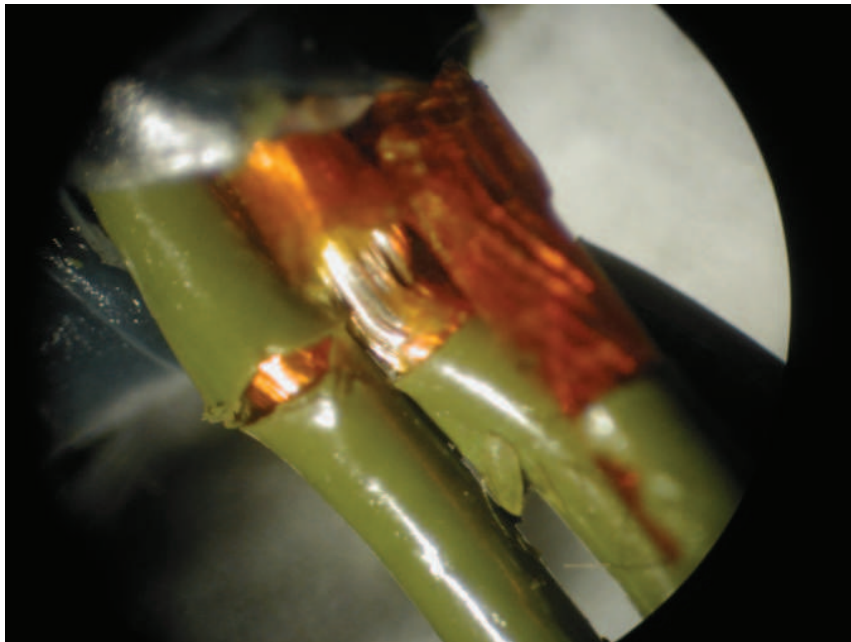
Figure 1: Harness 2601-Wires #082, #097: Insulation breach, multiple wires damaged – damage found at bundle intersection

Figure 1 above shows breaches were found while locating the failure of wire #082 in harness 2601. As can be seen in the photo, there is a breach in two wires with notable damage in the third wire. This photo was taken from one of the 23-year-old harnesses. A potential for a common mode failure exists in which multiple wires to short together. There was no evidence of external trauma that could have caused the breaches. It appears that aging of the polyimide may have been a significant factor in the formation of theses breaches. However, it is possible that the breaches were created during the manufacture of the harness.

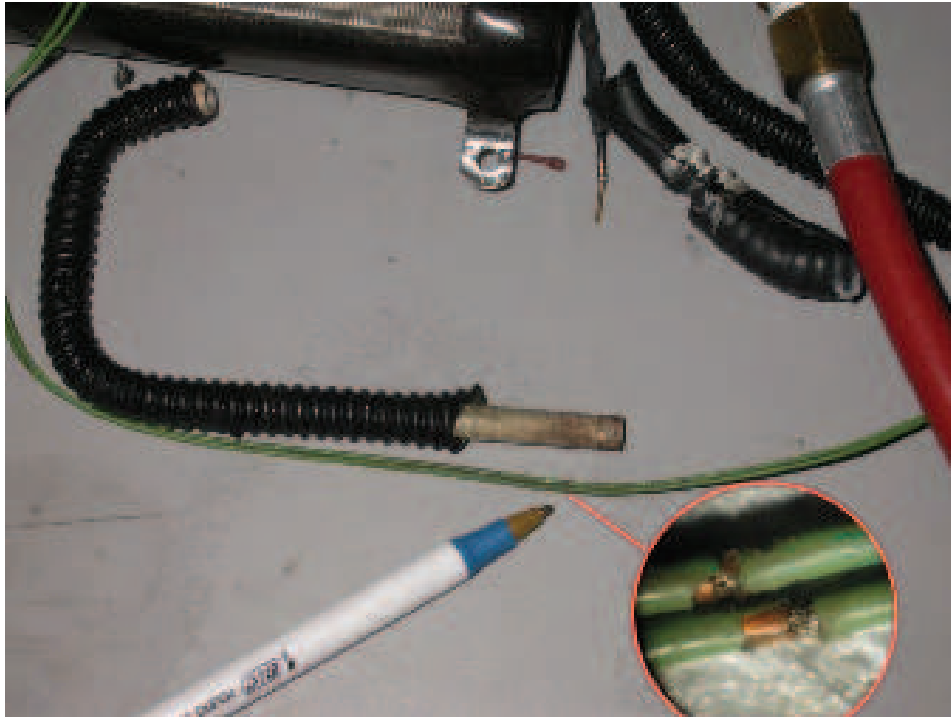
Figure 2: Harness 696-21 – Adjacent breaches that line up with the edge of a metal conduit that held the wire.

Figure 2 shows two adjacent breaches that are in line with the edge of a metal conduit. It is likely the chafing by the edge caused the insulation failure. Additional breach photos can be seen in Appendix A.

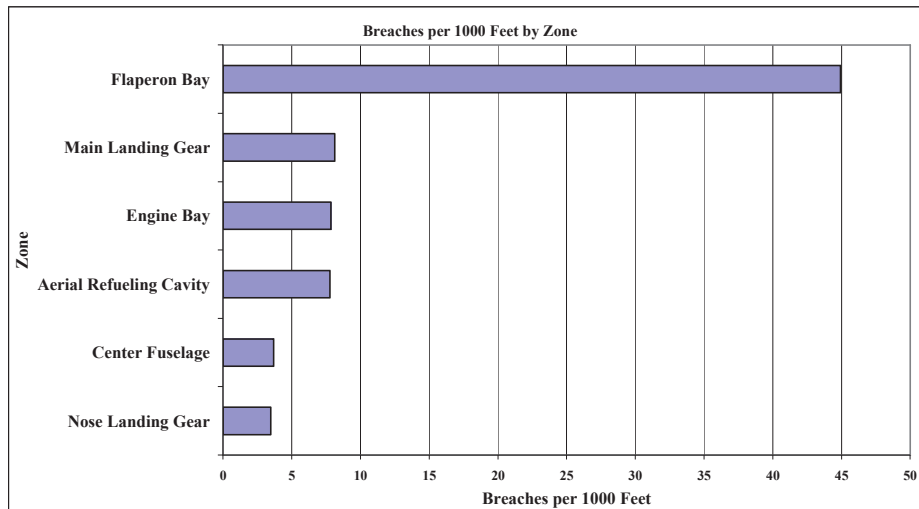
Figure 3 shows the breakdown of the wire breaches by the zones from which the harnesses were taken. The Flaperon Bay had the highest rate of failure with over 44 failures per 1000 feet of wire. However, because of the relatively small number of feet tested the high rate may be an anomaly. The lowest rate of breaches was the Nose Landing Gear with 3.47 per 1000 feet. Because of the limit amount of data, it is uncertain if the rate per zone shown in Figure 3 would be consistent throughout the fleet.

Figure 3: Breakdown of wire breaches per zone.

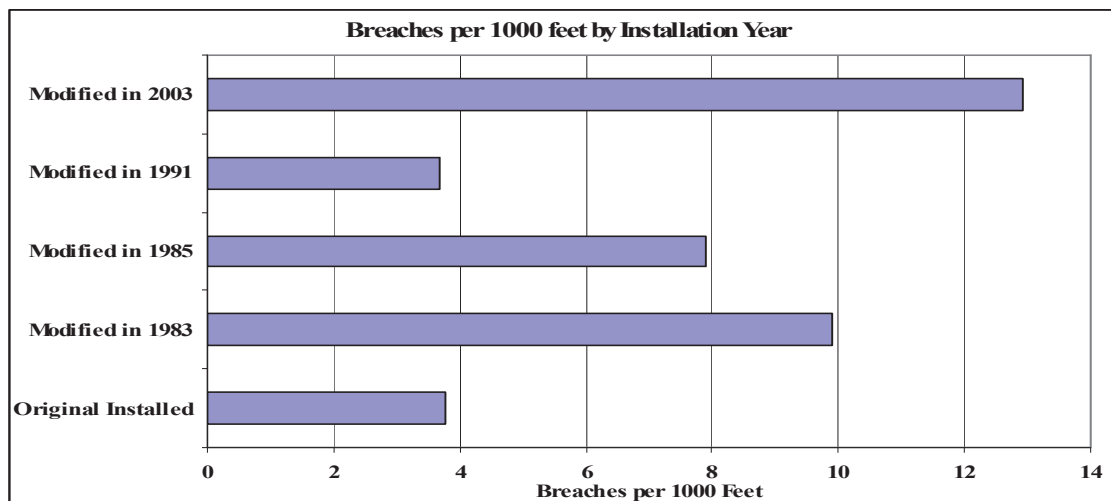
Figure 4: Breakdown of failures by age. Original Installed harnesses were built in 1982.

From the figure above, it does not appear as though there was a correlation between the age of the harness and the rates of breaches found. The reason for this is not clear but possible explanations include:

- The greatest number of failures per 1000 feet was found in those harnesses changed in 2003. Of the harnesses that were modified in 2003, most were installed in the engine area. This suggests that the engine area is a harsher environment than some of the other zones in the aircraft.
- The modification process may introduce breaches into the harness especially when the wire is aged. With the limit amount of data, it is uncertain whether this trend would continue through the fleet.

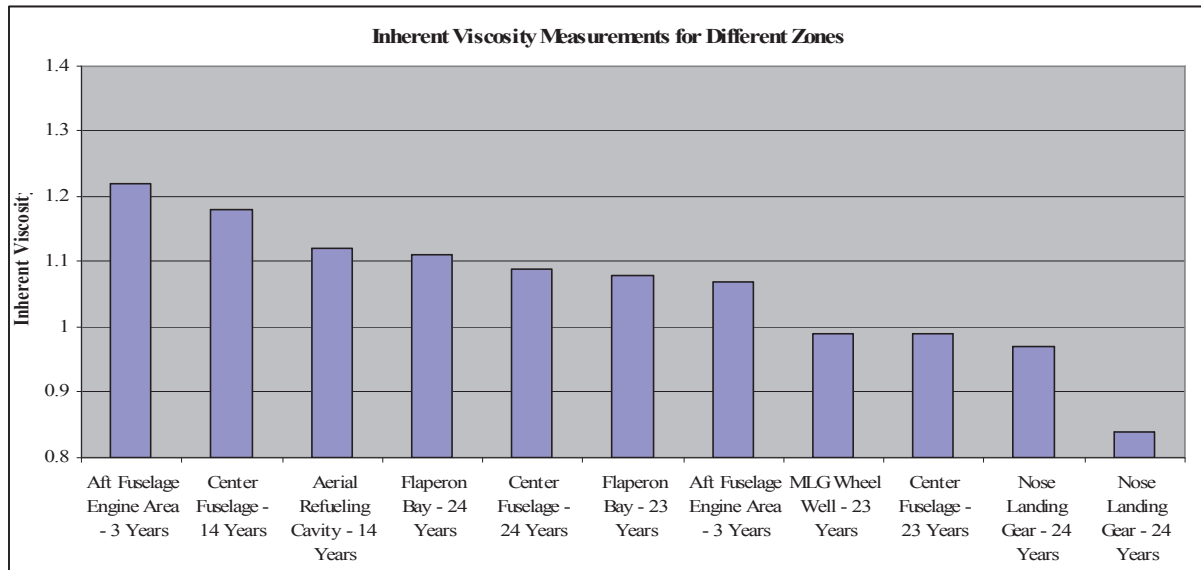
Figure 5: Inherent Viscosity measurements for different zones.

There is a notable difference in the values of the wires taken from the engine area harnesses, and it would appear as though the harnesses were exposed to different environmental conditions with perhaps one closer to the engine than the other. This variation of conditions and exposure to higher temperatures may explain why the engine harnesses on which Lectromec performed the DelTest™, most were only three years old. The result of the testing showed that the harnesses taken from the nose landing gear zones were the most severely aged with two of the four worst harnesses tested coming from that zone.

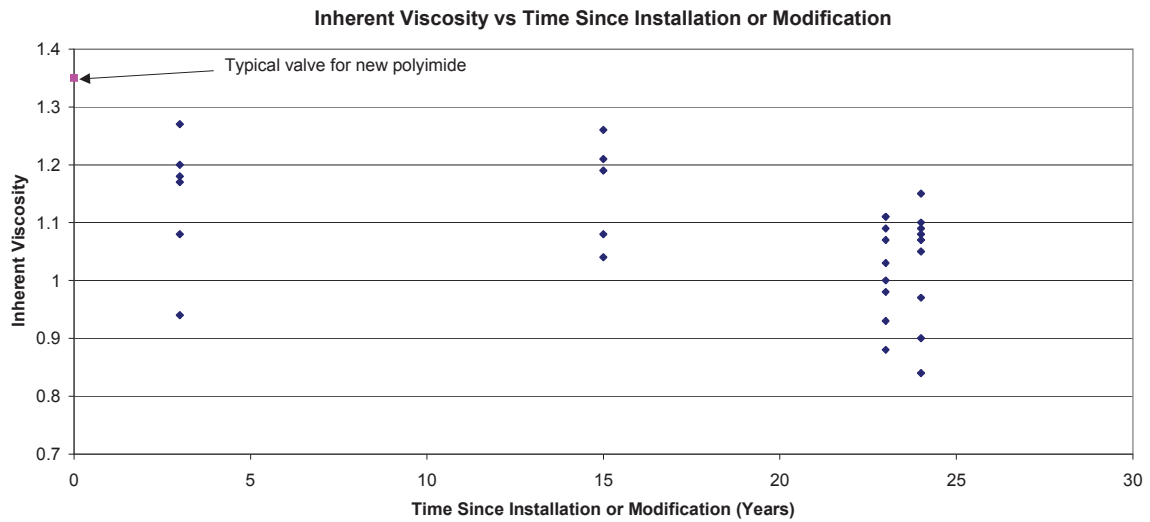
The results seen in Figure 6 are of the inherent viscosity versus the elapse time since the harness was installed or modified. Note that the data point at 0 years (1.35) is a typical value found for new polyimide film. In general, figure shows that there is a downward trend for the inherent viscosity as the wires ages; however, some wires from the harnesses at 3-year mark have inherent viscosity similar those from 24-year old harnesses. It is possible that the modifications that occurred 3 years ago (2003) did not fully replace the harness but simply changes some of the wire and left some older wire in place. The nature of the modifications done in 2003 is not known to the authors. However, an inherent viscosity of 0.94 for 3-year wire is surprisingly low and would be more consistent with an originally installed wire.

Figure 6: Inherent Viscosity versus time since the harness was modified.

If the inherent viscosity results shown in Figure 6 are tabulated, the insulation on 60% of the wires tested had an inherent viscosity of less than 1.1. In 25% of the wire the value was less than 1.0. Figure 7 shows the relationship between elongation at break and the inherent viscosity of the polymer. A new piece of polyimide tape has an elongation of between 90% and 100% corresponding to an inherent viscosity of between 1.3 and 1.4. A polyimide with an inherent viscosity of less than 1.0 has an elongation of 65% or less. This is a significant reduction and will make the insulation more susceptible to cracking or breaching.

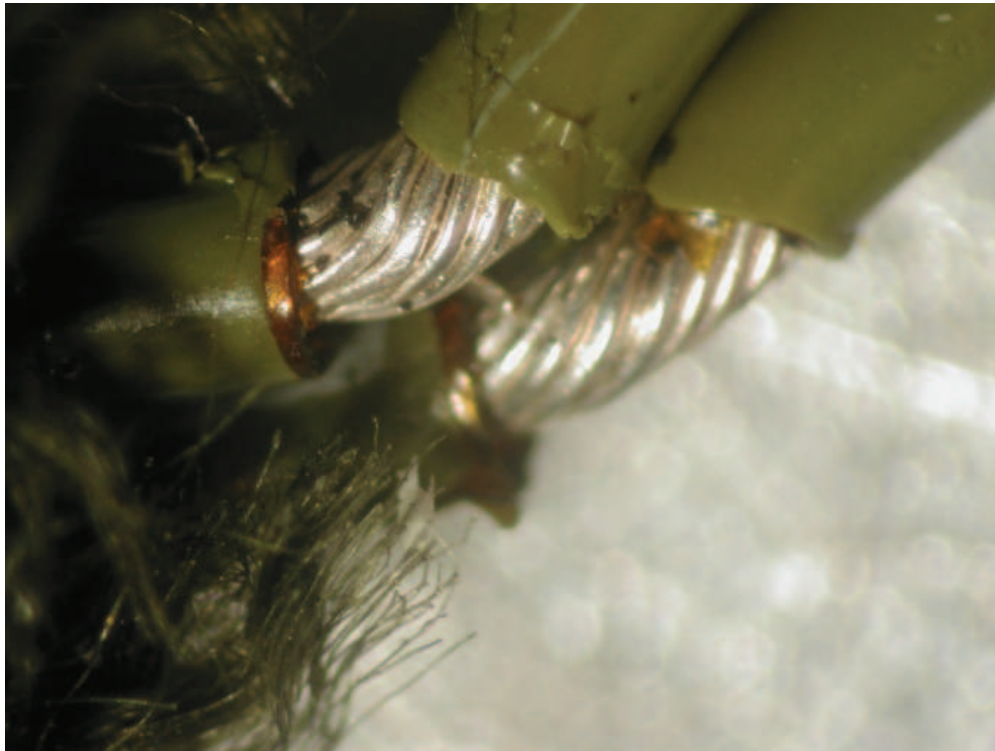
Figure 12: Harness 2601: Failure – wires # 042, 043 – Broken insulation found at harness intersection.

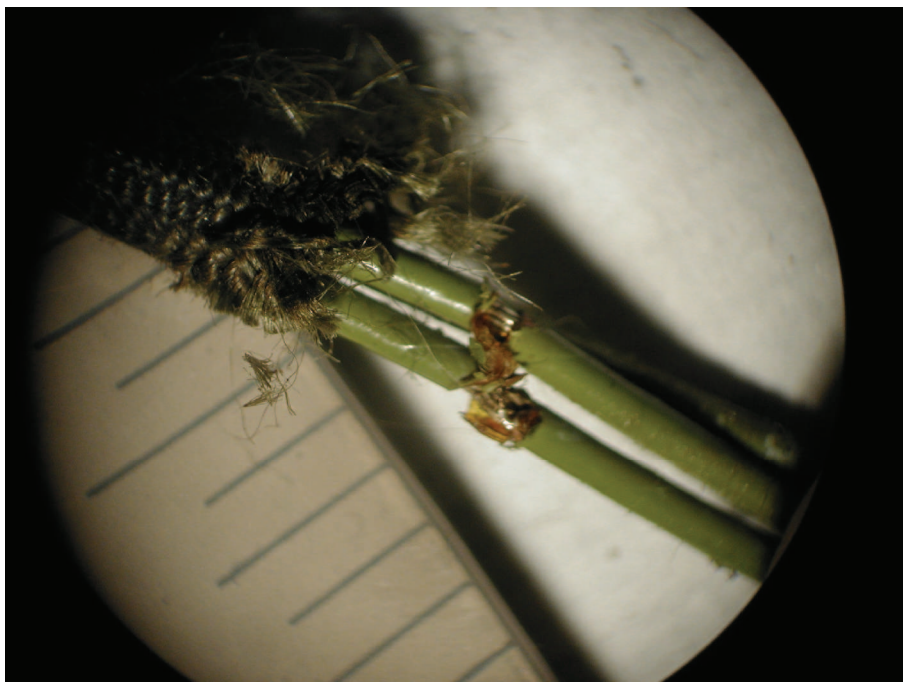
Figure 13: Harness 736. Breaches visible in wires #024 and #025. No damage seen to the third wire in the bundle.

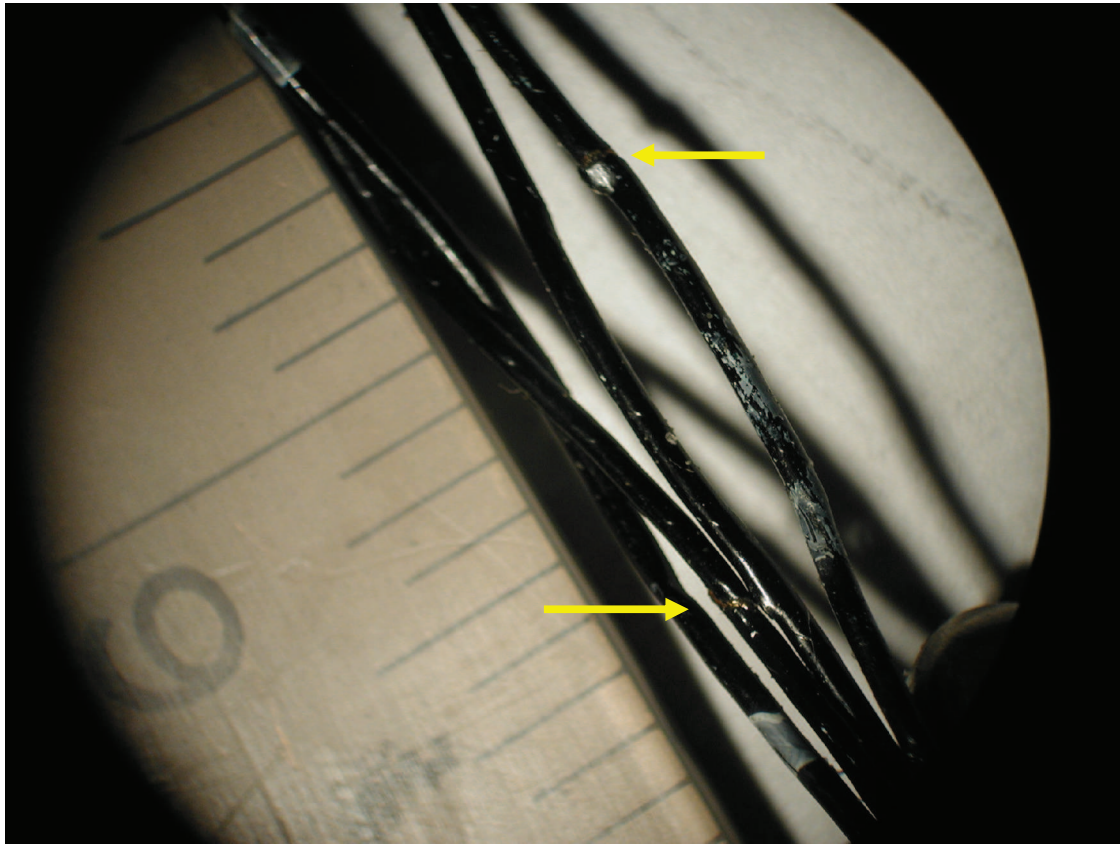
Figure 14: Originally DSCN5216.jpg: Harness 736 – breach visible in both wire 200 and 201.

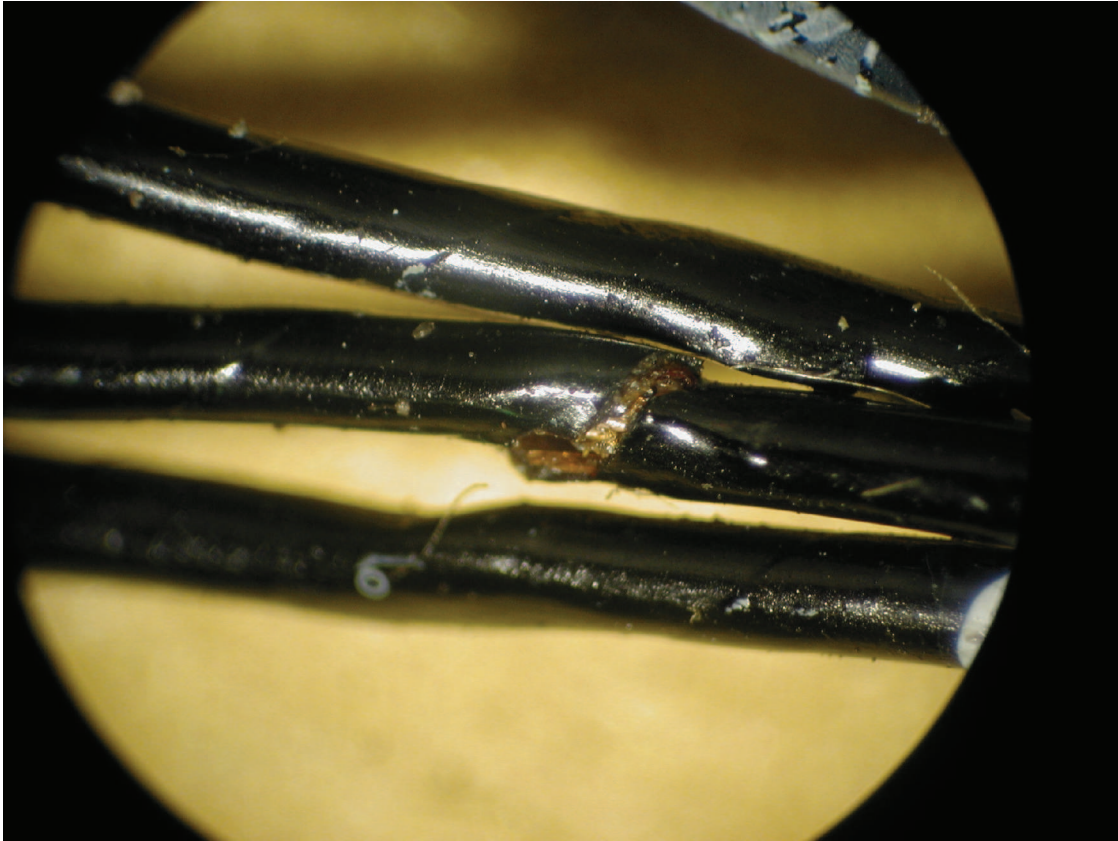
Figure 15: Originally DSCN5214.jpg: Harness 736. Wire (200). Break of insulation.

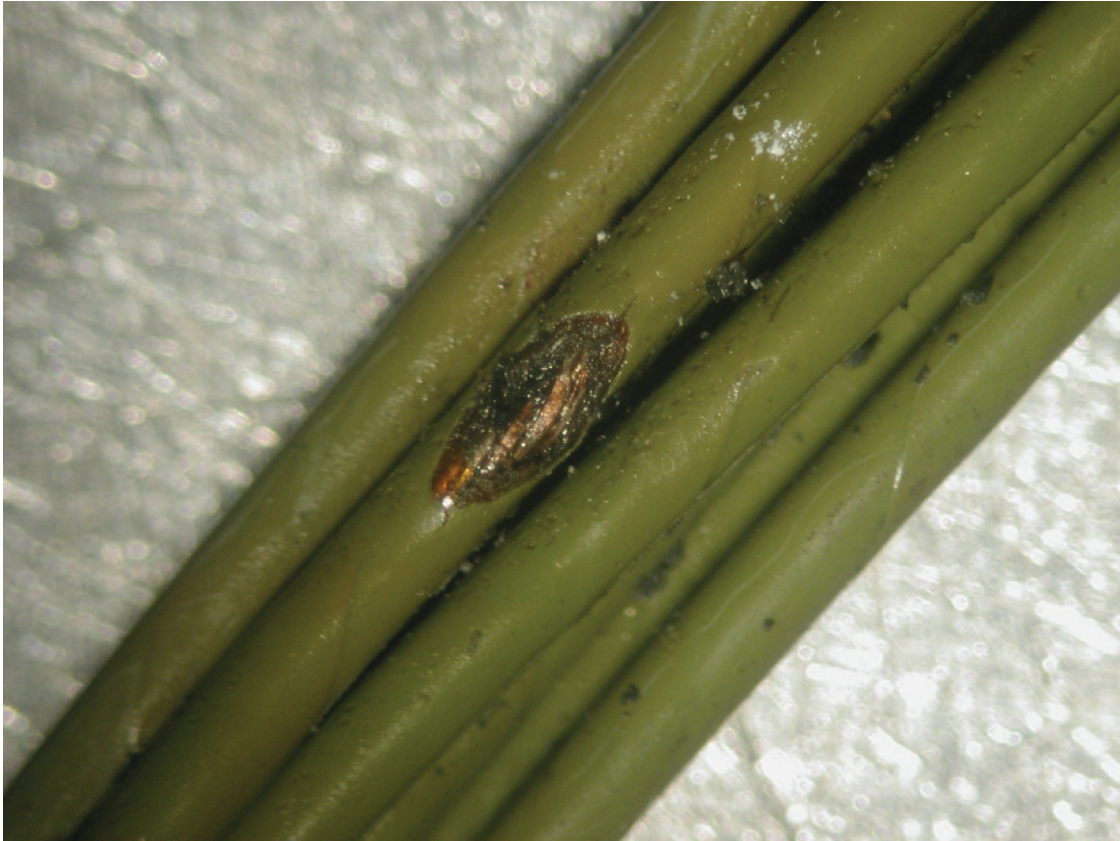
Figure 16: Harness 2601: Failure – wire #042 – insulation breeched.

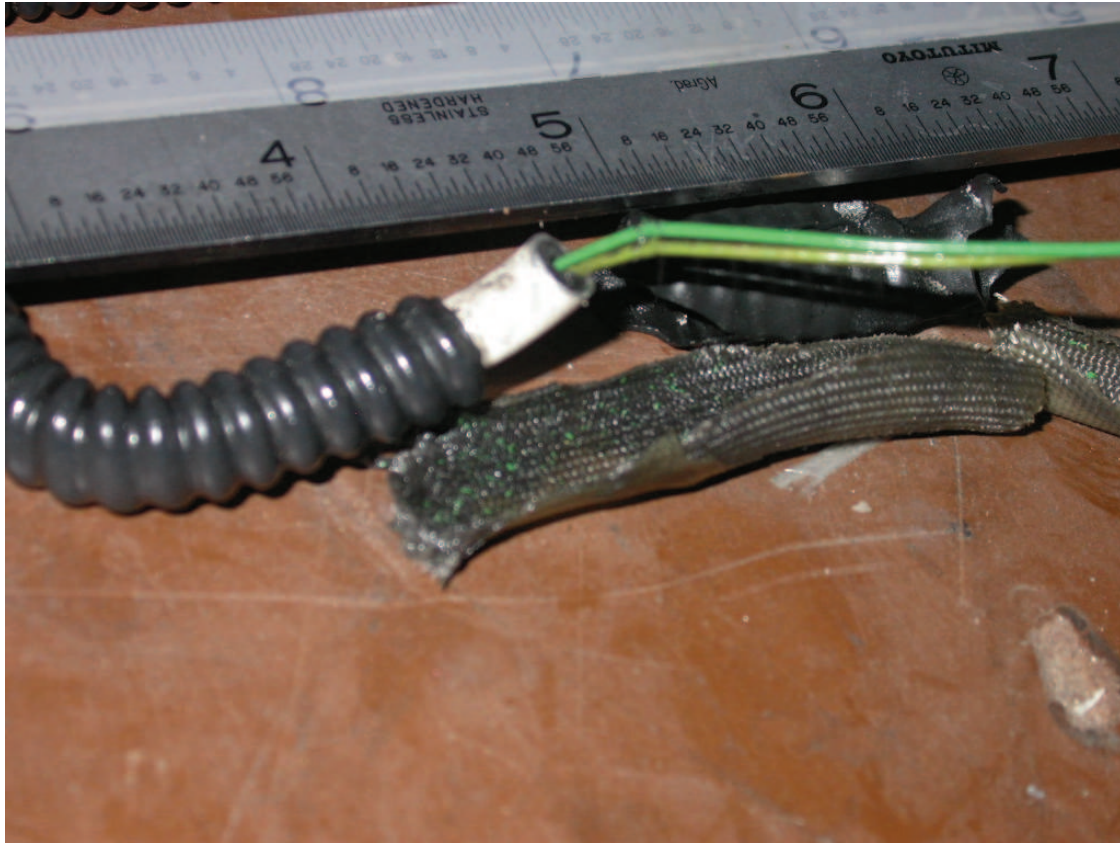
Figure 17: Harness 695-21 Breaches in both wires at edge of metal conduit (wires moved from edge for photo).

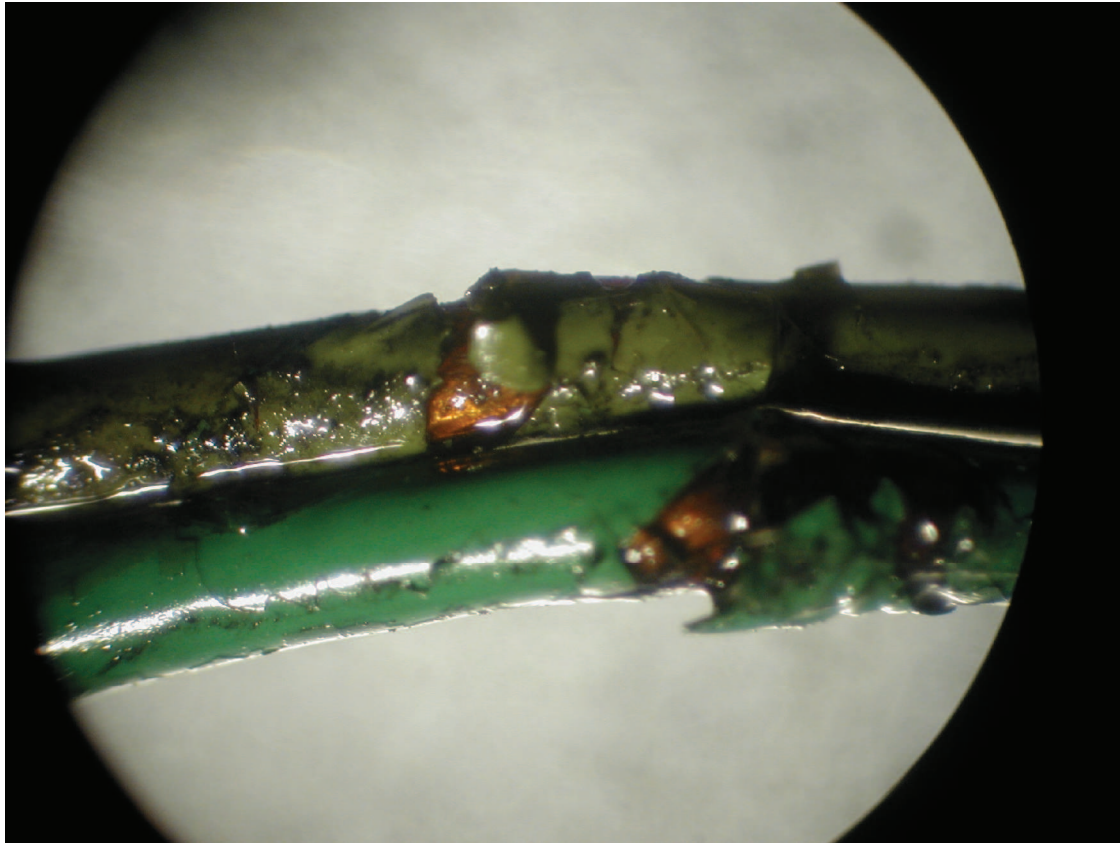
Figure 18: Harness 695-21 Breaches in both wire at edge of metal conduit.
