Examination of EWIS and Pressurized Hydraulic Lines

Mr. Michael G. Traskos, Dr. William G. Linzey, Mr. Stephen R. Traskos
Lectromechanical Design Company LLC
201 Davis Drive – Suite O
Sterling, Virginia 20164

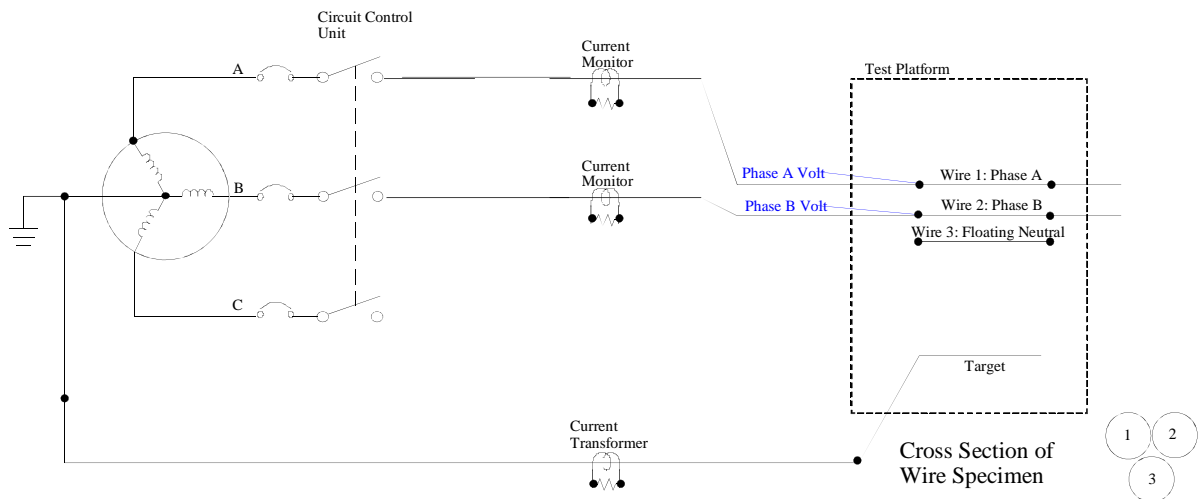
Figure 1: Circuit Diagram.

The following describes the test configurations. The test circuit can be seen in Figure 1. A 20kVA, 400 Hz, 3 phase generator was used as the power source. The test circuit has no circuit protection except for a circuit control unit (CCU) to remove system power after a predetermined duration. The CCU could be set to an accuracy of ± 10 ms.

The test wire bundle consisted of three 2AWG AS22759/87 wires. Two of the wires were pre-damaged either by a ring cut (similar to the one used in the wet arc track resistance testing AS4373 Method 509 shown in Figure 2) or sliver cuts (small sections of the wire insulation removed from the wire shown in Figure 3). The third wire in bundle was floating (not connected to power). The 2AWG pre-damaged wires were connected to separate phases of a 20kVA generator. The fault current for the circuit was 550Amps.

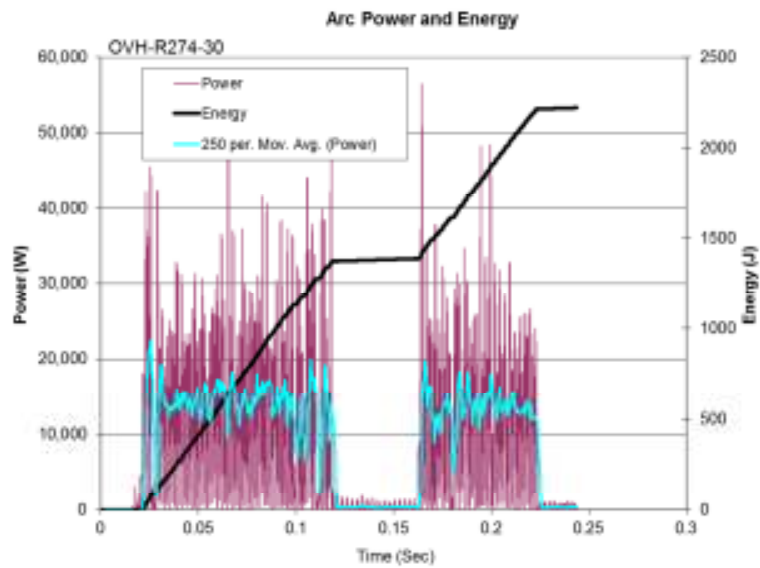
Figure 5: Power and Energy curves for the arcing event that ruptured the pressurized hydraulic tube.

During the testing phase, Lectromec performed a series of tests that examined different arc durations over different distances. The first group described here was performed with a 1.0inch separation between the pressurized tube and the arcing wires. Initial shorter duration tests allowed heat transfer parameters to be determined. One test in this series (OVH-R274-30) that resulted in a breach, had sporadic arcing lasting 200ms, energy output of 2219 Joules, and 606 Joules of direct arcing to the target. Figure 5 shows the energy and power plot for this experiment.

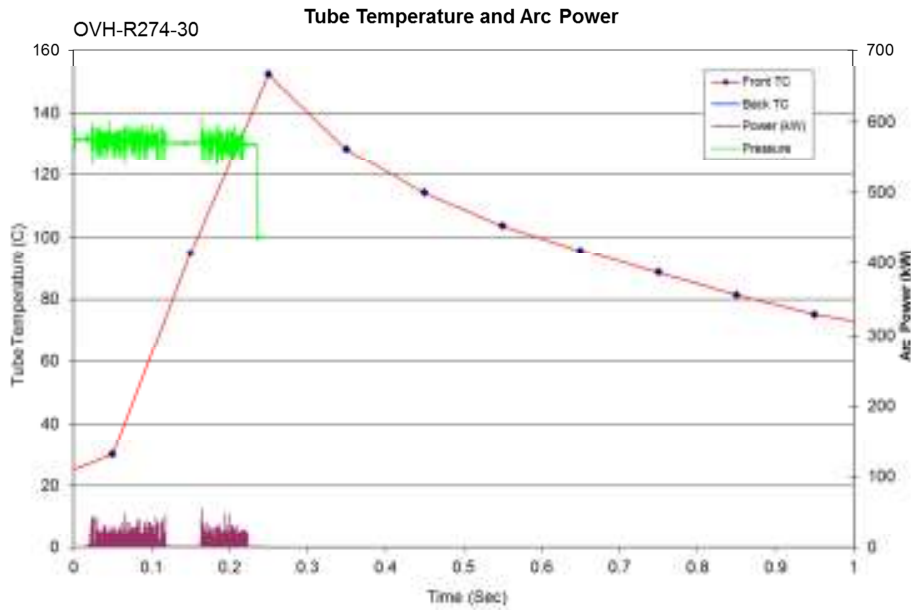
Figure 6: Pressure, temperature and power graphs for test with breach in hydraulic tube

Examination of the pressure data showed that the tube wall ruptured after the end of the arcing event had occurred. This would indicate that there was sufficient energy transferred to the aluminum tube (through direct arcing and heating from the arc plume) that the outward pressure breached the wall of the tube (Figure 6).

The maximum recorded temperature from this test was 157°C, but this was not at the site of the breach. The thermocouple was 1cm away from the arc location indicating that the highest temperature location was not captured in the test measurement. The data from this test could then be used with the ADMT to determine the failure temperature of the tube.

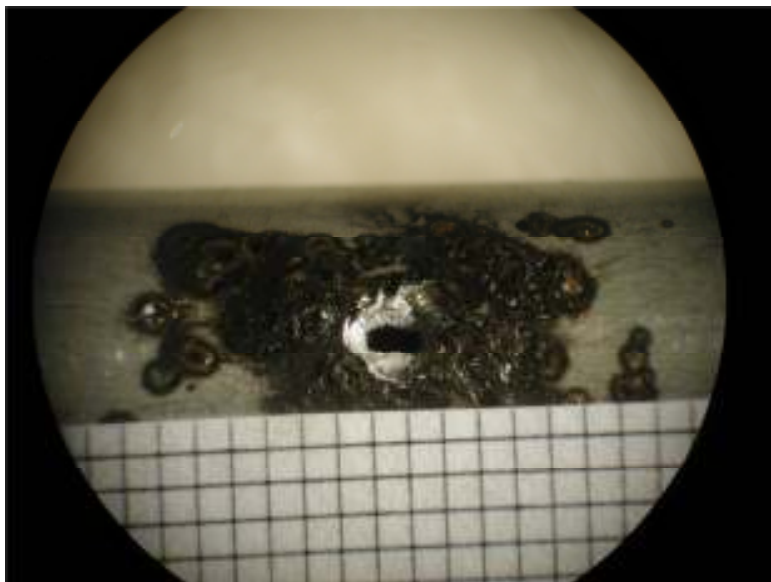
Figure 7: Breach created in 1.0 inch separation test.

The breach shown in Figure 7 was the most pronounced of the breaches that were seen in the hydraulic tubes. Other failures were seen as stress fractures and pinhole breaches. Sometimes these holes were so small that it was impossible to detect with an unaided visual examination.

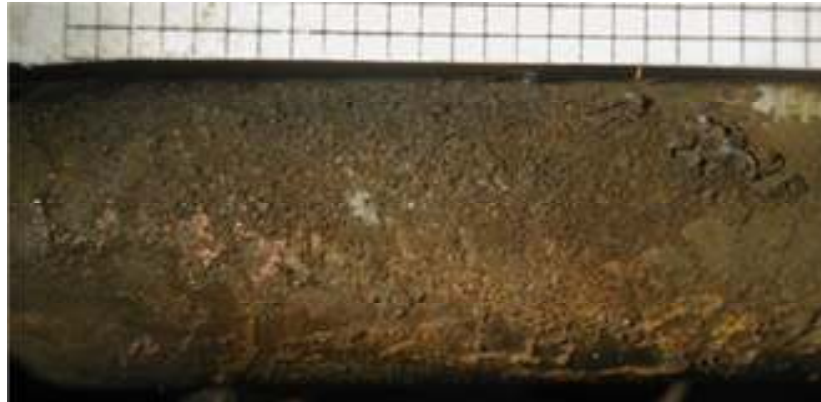
Figure 9: Posttest photo of target aluminum tube OVH-R274-46

Posttest examination of the target tube showed no pitting as typically seen in cases of direct arcing. The tube did show a large amount of copper residue and splatter from the arcing between the wires which could not be easily removed.

One of the changes that may have lowered the energy was that this test was performed with a ring cut in the arcing wires and not a sliver cut. It appears as though the direction of the arc plume is significantly affected if there is a ring cut in the wires (as in wet test specification SAE AS 4373 method 509) or if there is a nick in the wire insulation.

Some testing did not yield breached hydraulic lines. These tests helped set the upper boundary on the maximum temperature for a pressurized tube. Test OVH-R274-46 (seen in Figure 8) was performed with a two inch separation from the target. The arc duration was set to 2.4s and resulted in a total arc energy greater than 18kJ. Although this was a significantly longer event, the aluminum tube did not sustain the same level of damage as the previous example (Figure 9).

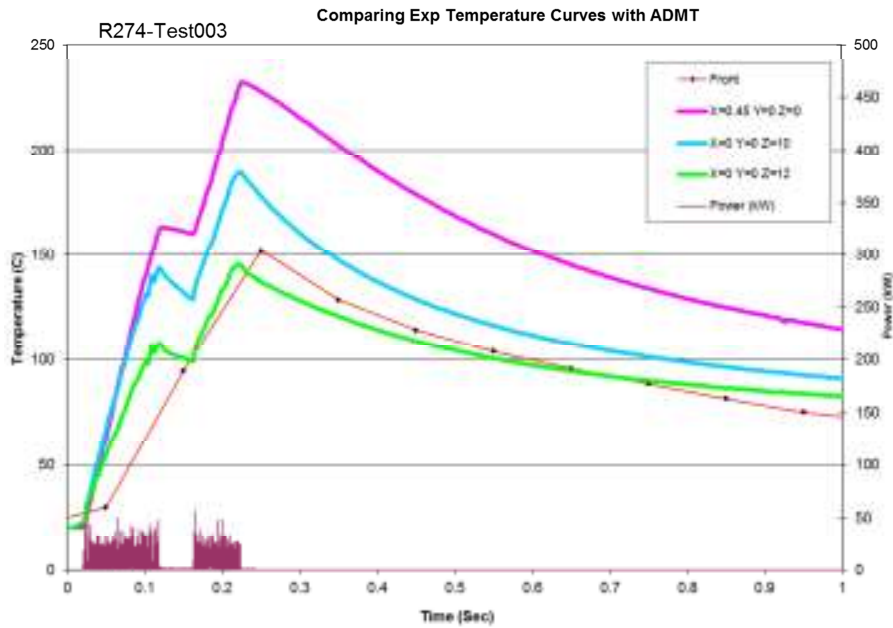
Figure 10: Simulation results of (OVH-R274-30)

Figure 10 shows the ADMT simulation results using the arc energy waveform from the experiment. The pink, cyan and green lines show the simulation temperature at three different locations. The green line is the simulated temperature measurement 12mm from the center of the arcing event. This shows close correlation with the measured temperature (the sampling rate of the temperature data recorder was 10 S/s).

At the center of the arc, the simulation suggests that the tube reached a maximum temperature of 232°C before breaching. The maximum simulated temperature indicates that this increase to 232°C is sufficient to create a breach. Simulations based on other testing showed similar limits.

To gather further information on the rupture temperature of the pressurized aluminum tubes, simulations were performed using the experimental data. As noted earlier, the breach in the tube wall from test (OVH-R274-30) was measured to be 11mm from the location of the thermocouple. To identify the temperature the tube had reached before rupture, the test parameters were entered into the ADMT.

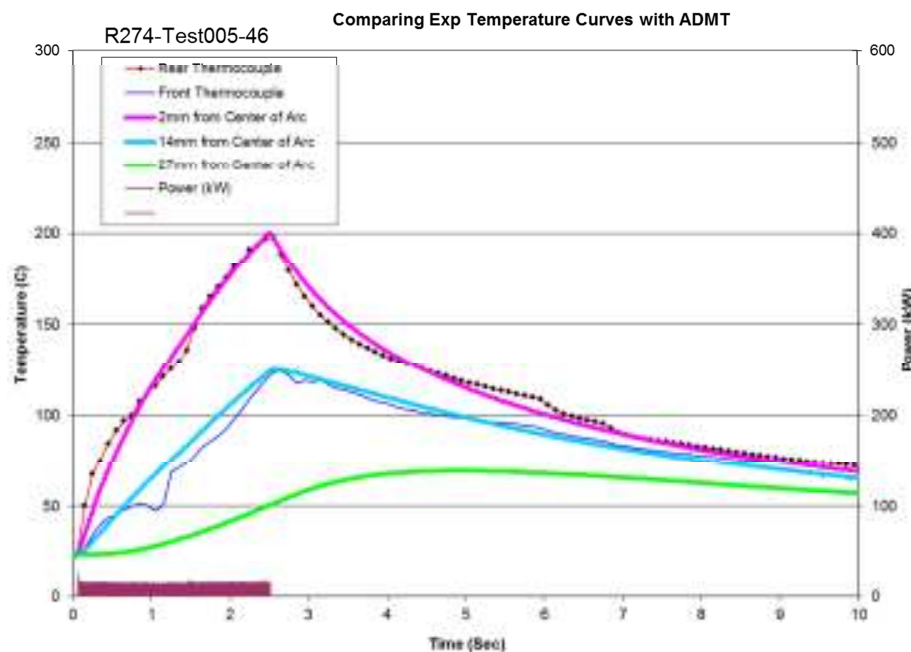
Figure 11: Simulation results of (OVH-R274-46) [no breach of hydraulic line]

Simulations were also performed on test that did not yield tube breaches. Figure 11 is an example of an ADMT simulation that as did not have a breach. In this test, two thermocouples 0.5inches apart were used. The simulations results show excellent correlation with the experimental data.

While there was significant energy transfer to the target, the target temperature was not high enough to cause a breach. The long duration of the arc event resulted in energy being thermally conducted away from the areas within the arc plume to the cooler areas. Further, the simulation shows good correlation with the experimental results at times long after the arc has completed. This was not the case in tests with breaches as the simulation does not account for the effects of moving fluids.
