Evaluation of Wire Harnesses Recently Removed from F-16 Aircraft

Abstract

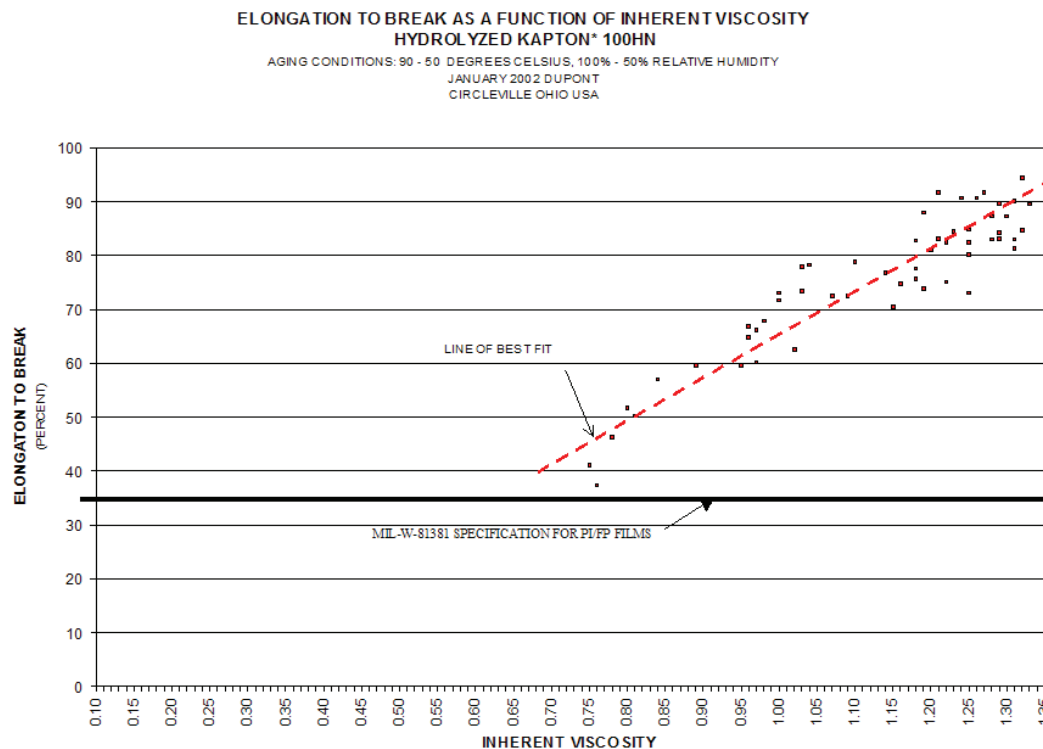
Figure 7: DuPont tests correlating inherent viscosity measurements with elongation to break[†].

If the inherent viscosity results shown in Figure 6 are tabulated, the insulation on 60% of the wires tested had an inherent viscosity of less than 1.1. In 25% of the wire the value was less than 1.0. Figure 7 shows the relationship between elongation at break and the inherent viscosity of the polymer. A new piece of polyimide tape has an elongation of between 90% and 100% corresponding to an inherent viscosity of between 1.3 and 1.4. A polyimide with an inherent viscosity of less than 1.0 has an elongation of 65% or less. This is a significant reduction and will make the insulation more susceptible to cracking or breaching.

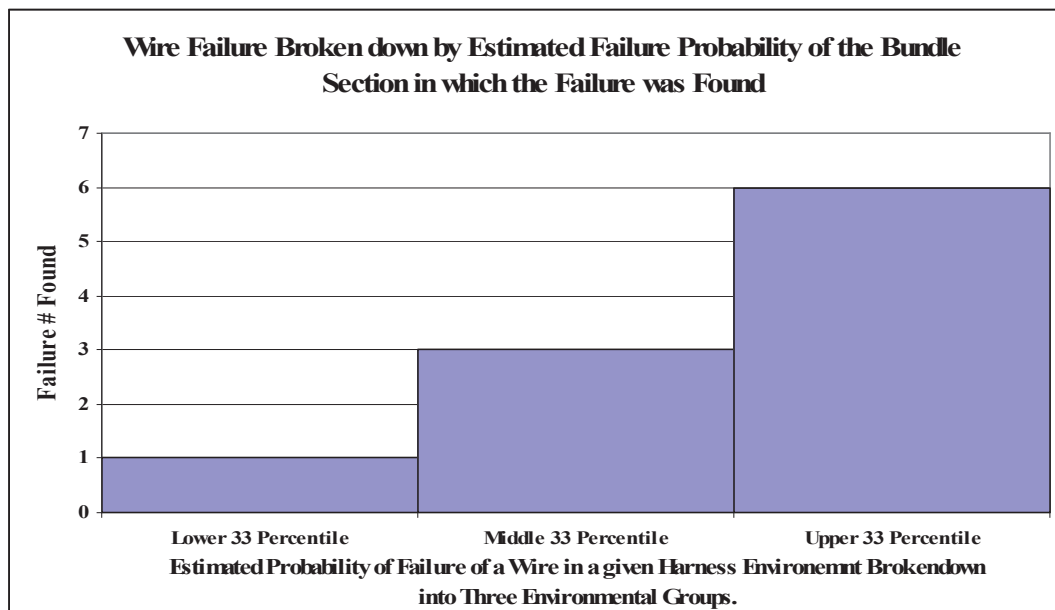
Figure 9: Breakdown of the Failures by the probability that a failure.

When comparing the known wire failure locations with the probability of failure of those bundle sections, most of the wire failures could be found in bundle sections, which were classified in the top third for probability of a wire failure. Though the results shown above are only for the four harnesses investigated, Lectromec would expect that this correlation would continue.

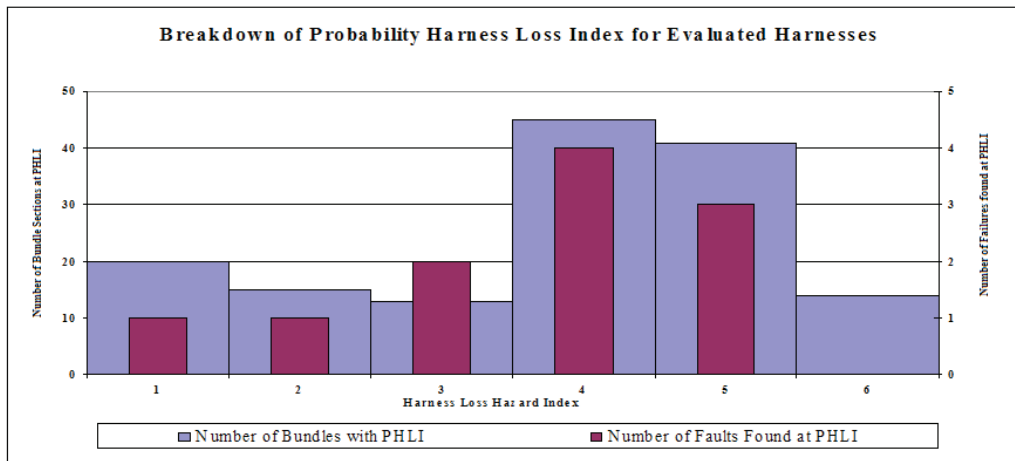
Figure 10: The above chart shows the breakdown of the number of the evaluated harnesses

Figure 10 shows the results of the breakdown of the evaluated bundles sections with regard to the PHLI. Additionally, the number of failures found in the bundle sections for a given PHLI rating can be seen in Figure 10. Most of the failures were found in bundle sections classified with a high PHLI rating (PHLI rating greater than 3). A positive result from this analysis is that none of the failures were found (at least as part of those harnesses investigated as part of the EWIS risk assessment) were classified as being part of a bundle section with the highest PHLI rating.

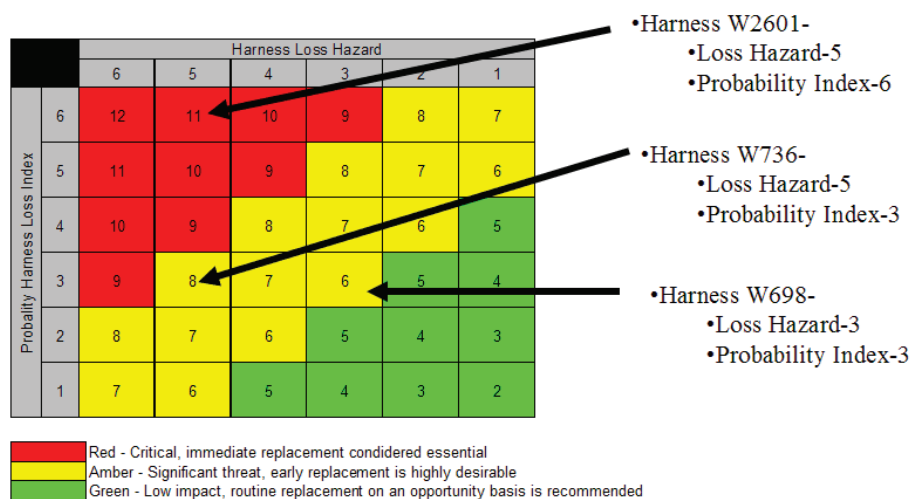
Figure 11: Placement of analyzed bundle section within the Risk Hazard Matrix.

Harness W2601 and W736 both can be considered important harnesses given that both contain systems which can be considered Flight Safety Critical. The last harness, W698, contains no systems which, if lost, would result in immediate flight safety concerns; this then places W698 as a lower priority harness with respect to the two. This information is taken and a Harness Loss Hazard Index is assigned to each harness.

Combining the information from the PHLI and the importance of each harness based on the systems within the harnesses, the evaluated harnesses were assigned a value and reported in a hazard matrix. The placement of each harness within the Risk Hazard Matrix can be seen below in Figure 11.

The results from this analysis show that the three evaluated harnesses were classified as critical or significant impact harnesses; analysis of additional harnesses would likely show an even breakdown between the three categories within the risk hazard matrix. The Risk Hazard Matrix seen here is directed toward rewiring efforts and the selection of harnesses for replacement, but could be expanded to account for other aspects that are important to the EWIS maintenance process.

Red – Those systems within the harness can be considered critical harness and there exists an immediate need for the replacement.

Amber – Those systems within the harness can be considered important and replacement of these harnesses is highly desirable.

Green – These systems within the harness are of lower importance and the replacement of these harnesses is not of an immediate concern
